COMMON SEAL FAILURES

O-RING FAILURE ANALYSIS

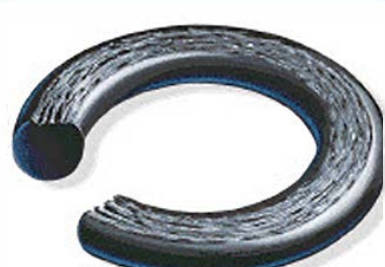
ABRASION

Description: The seal or parts of the seal exhibit a flat surface parallel to the direction of motion. Loose particles and scrapes may be found on the seal surface.

Contributing Factors: Rough sealing surfaces. Excessive temperature. Process environment containing abrasive particles. Dynamic motion. Poor elastomer surface finish.

Suggested Solutions: Use recommended gland surface finishes. Consider internally lubed elastomers. Eliminate abrasive components.

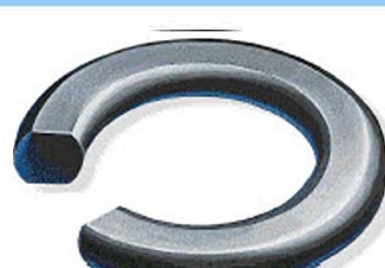
COMPRESSION SET

Description: The seal exhibits a flat-sided cross-section, the flat sides corresponding to the mating seal surfaces.

Contributing Factors: Excessive compression. Excessive temperature. Incompletely cured elastomer. Elastomer with high compression set. Excessive volume swell in chemical.

Suggested Solutions: Low compression set elastomer. Proper gland design for the specific elastomer. Confirm material compatibility.

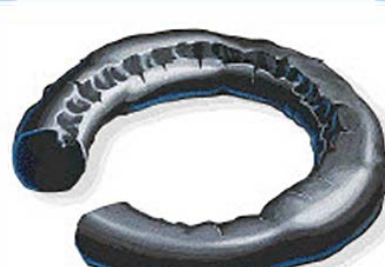
CHEMICAL DEGRADATION

Description: The seal may exhibit many signs of degradation including blisters, cracks, voids or discoloration. In some cases, the degradation is observable only by measurement of physical properties.

Contributing Factors: Incompatibility with the chemical and/or thermal environment.

Suggested Solutions: Selection of more chemically resistant elastomer.

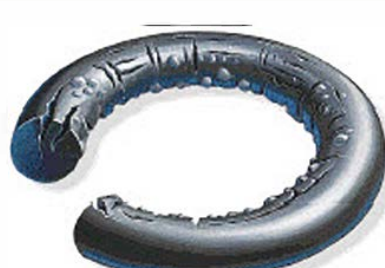
EXPLOSIVE DECOMPRESSION

Description: The seal exhibits blisters, pits or pocks on its surface. Absorption of gas at high pressure and the subsequent rapid decrease in pressure. The absorbed gas blisters and ruptures the elastomer surface as the pressure is rapidly removed.

Contributing Factors: Rapid pressure changes. Low-modulus/hardness elastomer.

Suggested Solutions: Higher-modulus/hardness elastomer. Slower decompression (release of pressure).

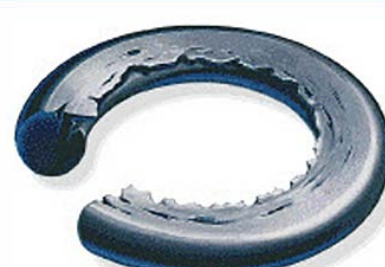
EXTRUSION

Description: The seal develops ragged edges (generally on the low-pressure side) which appear tattered.

Contributing Factors: Excessive clearances. Excessive pressure. Low-modulus/hardness elastomer. Excessive gland fill. Irregular clearance gaps. Sharp gland edges. Improper sizing.

Suggested Solutions: Decrease clearances. Higher-modulus/hardness elastomer. Proper gland design. Use of polymer backup rings.

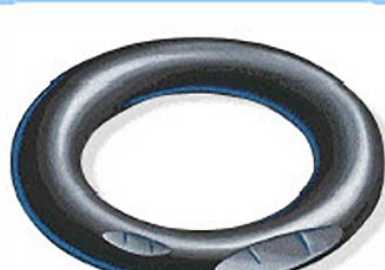
INSTALLATION DAMAGE

Description: The seal or parts of the seal may exhibit small cuts, nicks or gashes.

Contributing Factors: Sharp edges on glands or components. Improper sizing of elastomer. Low-modulus/hardness elastomer. Elastomer surface contamination.

Suggested Solutions: Remove all sharp edges. Proper gland design. Proper elastomer sizing. Higher-modulus/hardness elastomer.

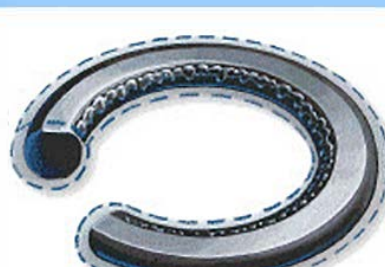
OUTGASSING / EXTRACTION

Description: This failure is often very difficult to detect from examination of the seal. The seal may exhibit a decrease in cross-sectional size.

Contributing Factors: Improper or improperly cured elastomer. High vacuum levels. Low hardness/plasticized elastomer.

Suggested Solutions: Avoid plasticized elastomers. Ensure all seals are properly post-cured to minimize outgassing.

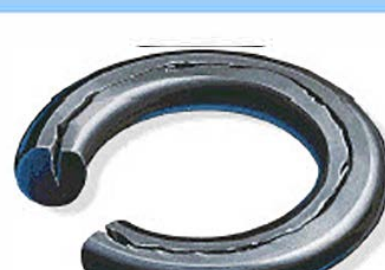
OVERCOMPRESSION

Description: The seal exhibits parallel flat surfaces (corresponding to the contact areas) and may develop circumferential splits within the flattened surfaces.

Contributing Factors: Improper design—failure to account for thermal or chemical volume changes, or excessive compression.

Suggested Solutions: Gland design should take into account material responses to chemical and thermal environments.

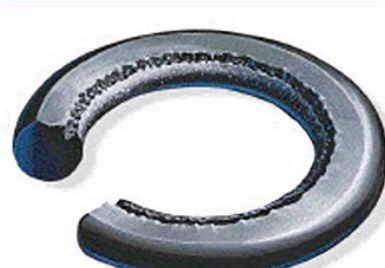
PLASMA DEGRADATION

Description: The seal often exhibits discoloration, as well as powdered residue on the surface and possible erosion of elastomer in the exposed areas.

Contributing Factors: Chemical reactivity of the plasma. Ion bombardment (sputtering). Electron bombardment (heating). Improper gland design. Incompatible seal material.

Suggested Solutions: Plasma-compatible elastomer and compound. Minimize exposed area. Examine gland design.

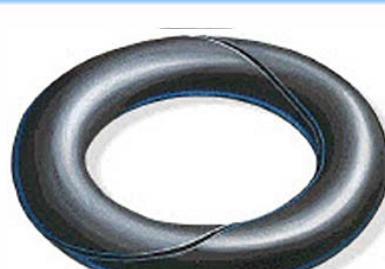
SPIRAL FAILURE

Description: The seal exhibits cuts or marks which spiral around its circumference.

Contributing Factors: Difficult or tight installation (static). Slow reciprocating speed. Low-modulus/hardness elastomer. Irregular O-ring surface finish (including excessive parting line). Excessive gland width. Irregular or rough gland surface finish. Inadequate lubrication.

Suggested Solutions: Correct installation procedures. Higher-modulus elastomer. Internally-lubed elastomers. Proper gland design. Gland surface finish of 8–16 microinch RMS. Possible use of polymer backup rings.

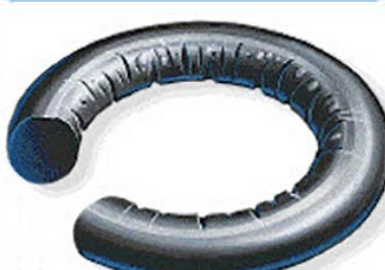
THERMAL DEGRADATION

Description: The seal may exhibit radial cracks located on the highest temperature surfaces. In addition, certain elastomers may exhibit signs of softening—a shiny surface as a result of excessive temperatures.

Contributing Factors: Elastomer thermal properties. Excessive temperature excursions or cycling.

Suggested Solutions: Selection of an elastomer with improved thermal stability. Evaluation of the possibility of cooling sealing surfaces.
